Asset Vulnerability Assessment Project

Part 2 – Case Studies Overview

Prepared for: South East Councils Climate Change Alliance (SECCCA)

22/12/2021

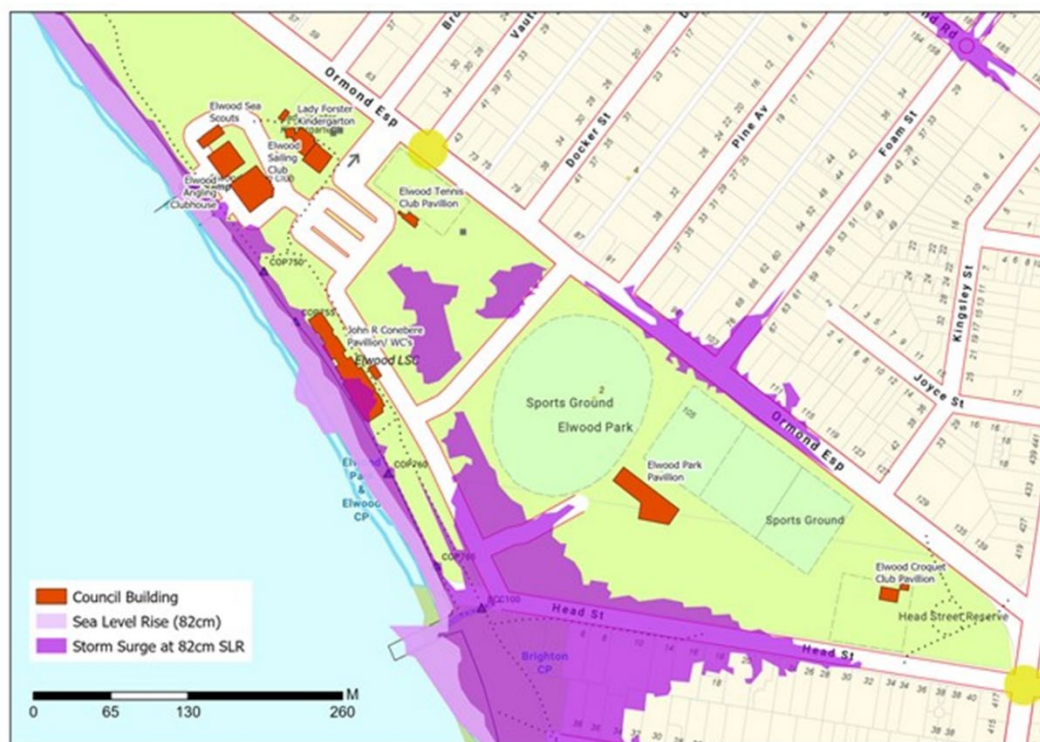
Figure 2. Coastal inundation caused by sea level rise and storm surge at the Elwood Foreshore.

Many of the Council buildings are reaching their end of life and are subject to high maintenance costs due to their age, poor condition, compliance and accessibility issues. Some of the buildings are also heritage listed. The Life Saving Club and the restaurant, in particular, are vulnerable to the risks of inundation from storm surges (exacerbated by sea level rise) and inland flooding. This is affecting insurance costs. The likely extent of coastal inundation in the area is shown in Figure 2.

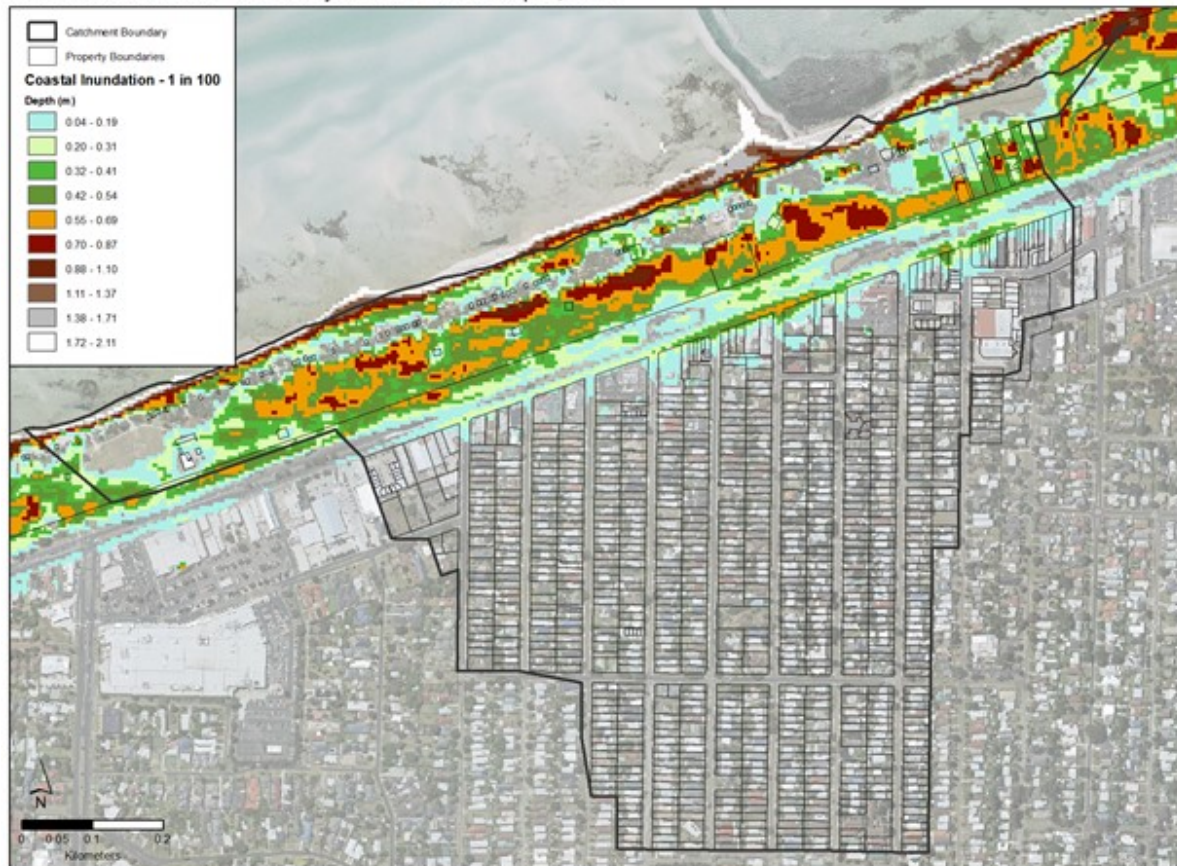
Coastal Inundation - 1 in 100 year extent and depth, 2030

Figure 4. 1 in 100 year coastal inundation at Rosebud
